Building Report

4 Percy Green Silverdale

Date of Inspection 21 October 2016

HOUSE INSPECTION AT 4 Percy Green Silverdale

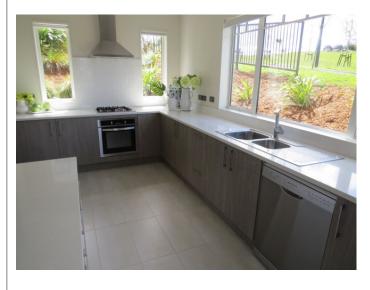
The kitchen is in good condition. All appliances and fittings are in good working order.

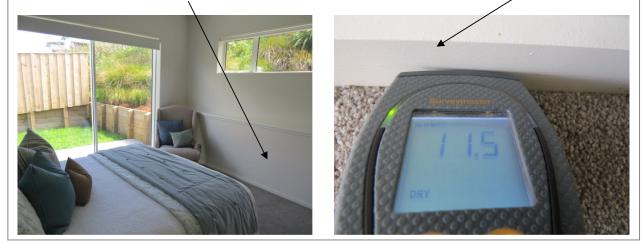
All moisture readings are well within acceptable limits. Retaining wall behind bedroom 1 shows no detectable signs of dampness.

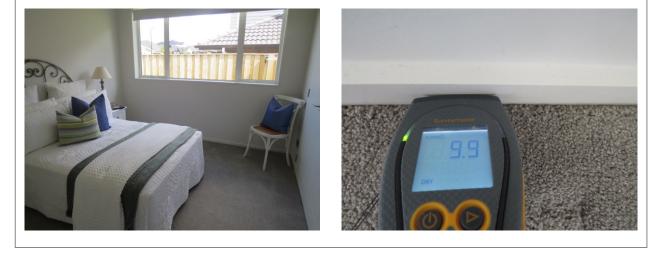
All moisture readings are well within acceptable limits.

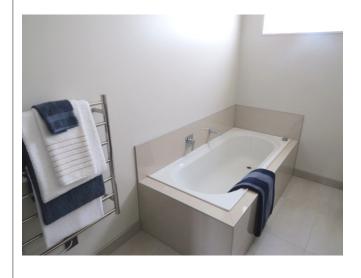
The bathroom is in good condition.

All plumbing and fittings are in good working order.

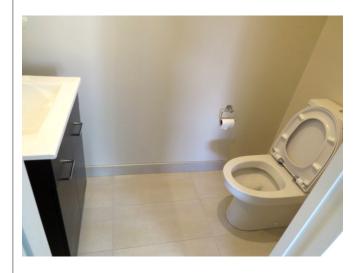
The toilet is in good condition.

All plumbing and fittings are in good working order.

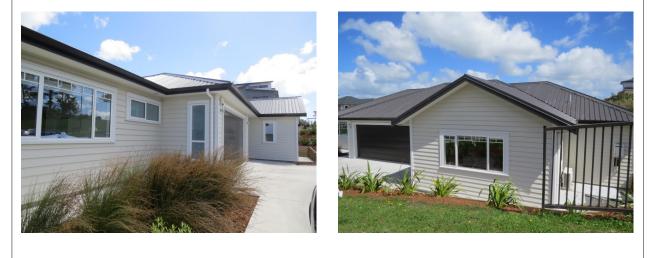
The timber weather boards are well painted and have been fixed over a ventilated cavity system.

The aluminium windows all have head flashings and are weathertight. Keep exterior door sills and tracks clean and free of debris to help prevent moisture ingress.

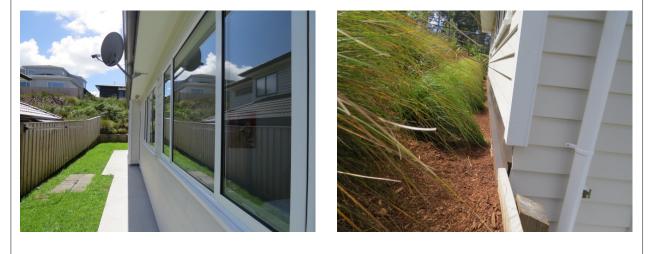
The timber weather boards are well painted and have been fixed over a ventilated cavity system.

The aluminium windows all have head flashings and are weathertight.

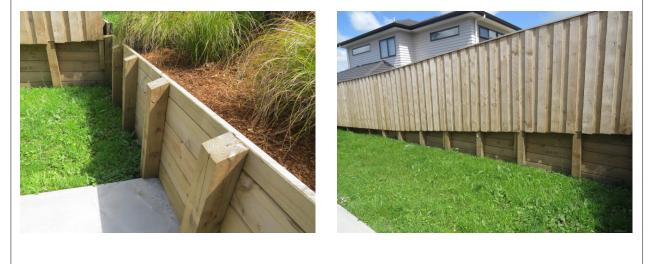
The section has been cut and filled to a near level building site.

The timber retaining wall is stable and in good condition.

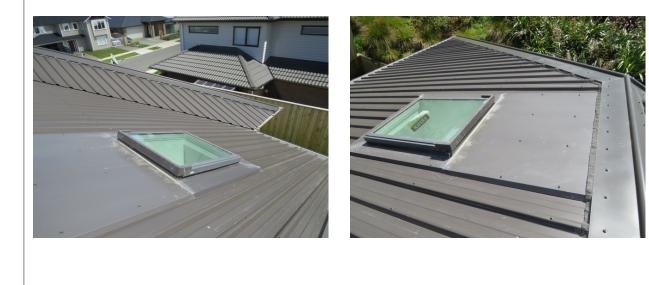
The coloursteel roof is in good condition. There are no signs of possible leaks.

Recommend cleaning roof.

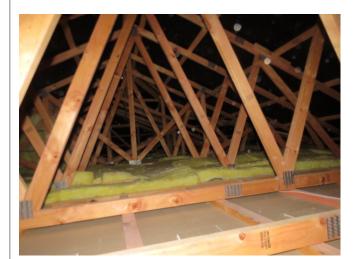
The roof is framed with timber trusses. There are no signs of decay or borer in the framing.

The ceiling is insulated with fiberglass batts.
